Manhole Inspection Summary

Manhole # S23GG1005MH

Insp Date: **12/11/06 2:21 PM**

Location Address: **4105 Buena Vista- Edge Hill**

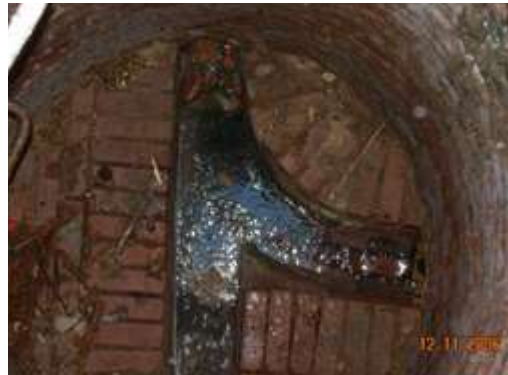
Top View

Bench and channel debris, corroded step

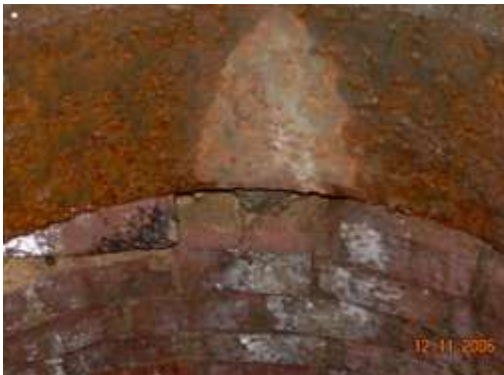
Defect

Frame leaks. Adjustment loose brick.
Adjustment infiltration.

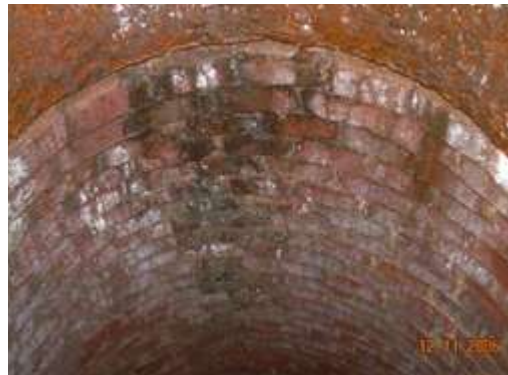
Defect

Frame Leak, adjustment infiltration.

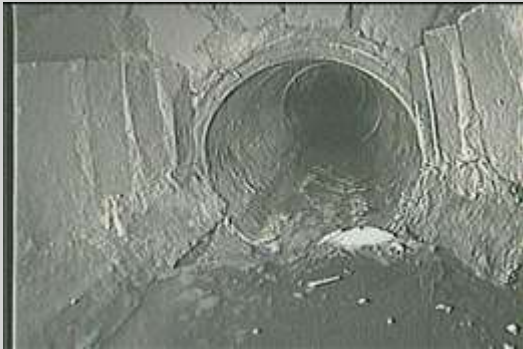
8 in. Circular Gravity Sewer Pipe Out @ 12 O'Clock

Infiltration: **Evidence** Pipe Seal Cond: **Unknown**
